UNITED STATES ENVIRONMENTAL PROTECTION AGENCY
REGION 8

Re: NPDES Inspections, NPDES Permit Numbers – NDR12A95I, NDR12A98I and NDR12A96I

On July 22, 2015, the Environmental Protection Agency (EPA) conducted site inspections at the Black Eagle Estates (NDR12A95I), the Mandaree Pow Wow Grounds (NDR12A98I) and the White Oak Park (NDR12A96I), located in Mandaree, North Dakota. The EPA inspectors Monia Ben-Khaled and Kacy Sable conducted the inspections to determine compliance of construction activities at the three sites with the Federal Stormwater General Permit (Permit) requirements. At the time of the inspection, there were no construction personnel present at the sites. The EPA inspectors walked around the three sites and took photographs of observations at the Black Eagle Estates and the White Oak Park.

Photographs for Black Eagle Estates

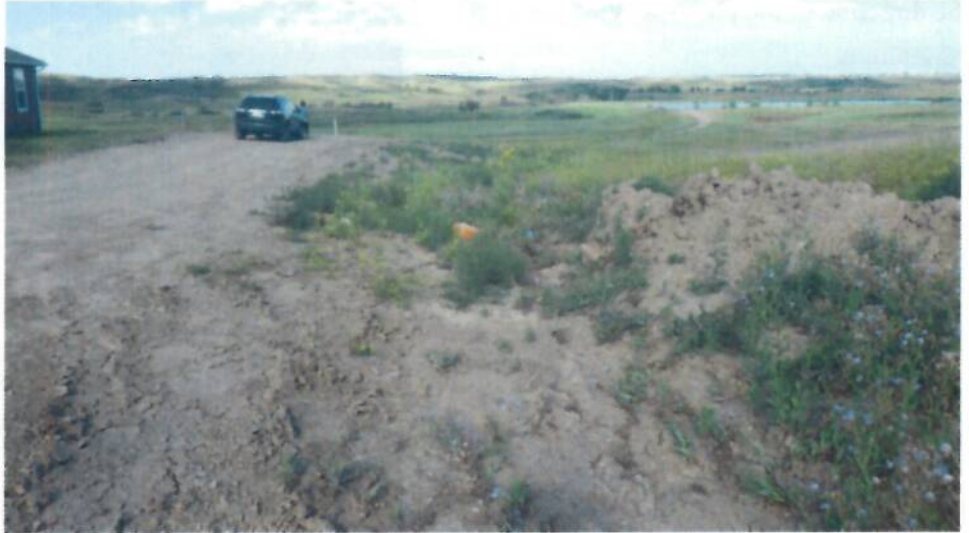
Photo Number: 428
Photo Date/Time: 7/22/2015
Photographer: Kacy Sable
The direction of the photo is West.

A drainage swale by the road on the south side of the subdivision. The Mandaree wastewater lagoon is shown on the far back of the photo.

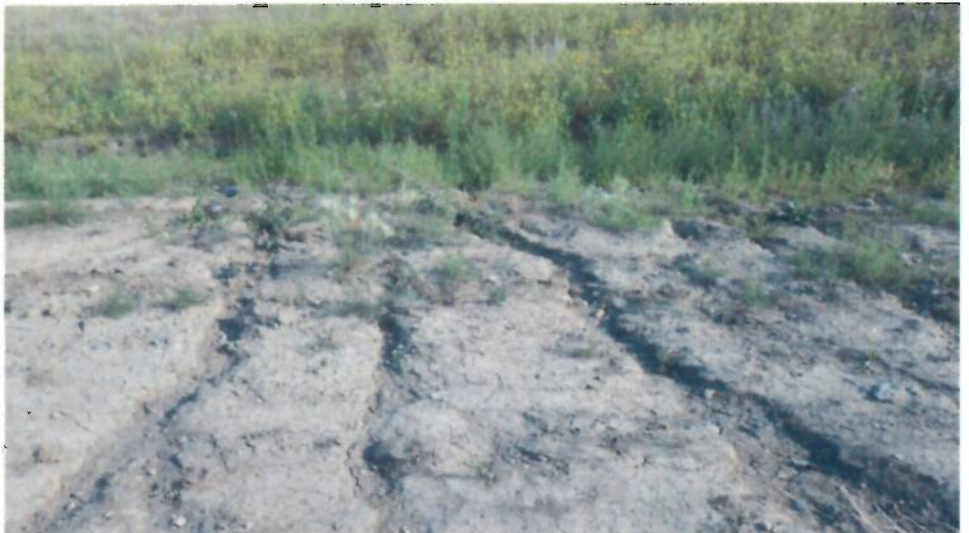
Photo Number: 429
Photo Date/Time: 7/22/2015
Photographer: Kacy Sable
The direction of the photo is North.

Erosional rills observed while walking down from where photo 428 was taken. Note the lack of stabilization.

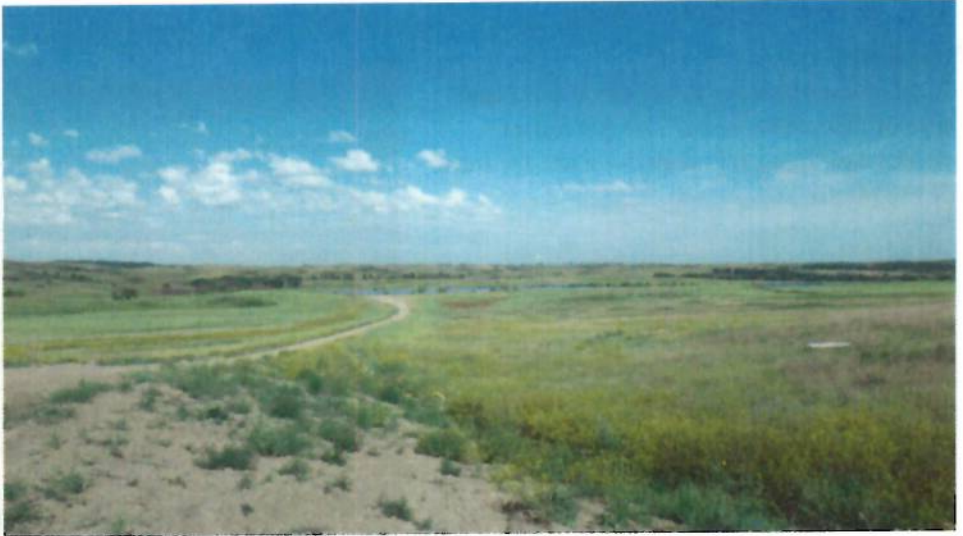
Photo Number: 431

An overview of the northern side of the subdivision.

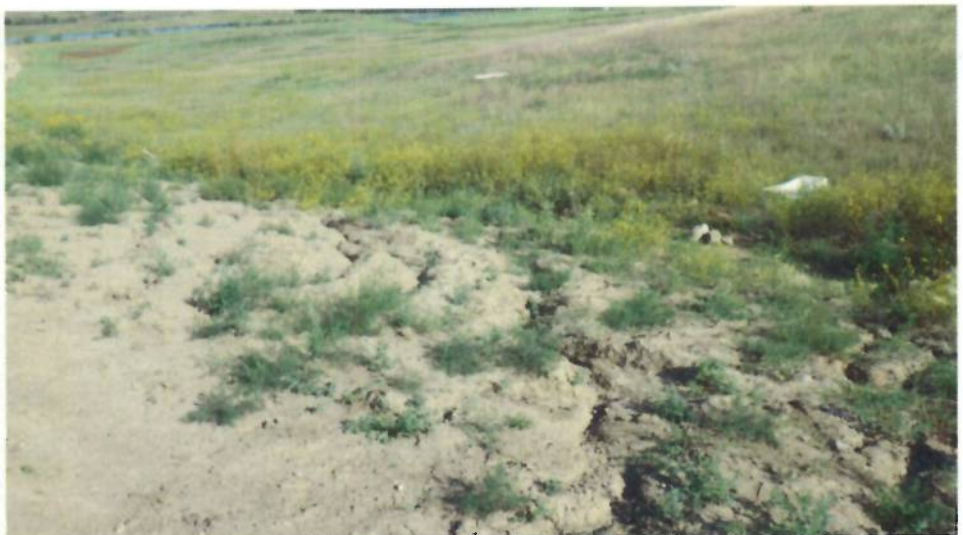
Photo Number: 432

More erosional rills on the northern side of the subdivision.

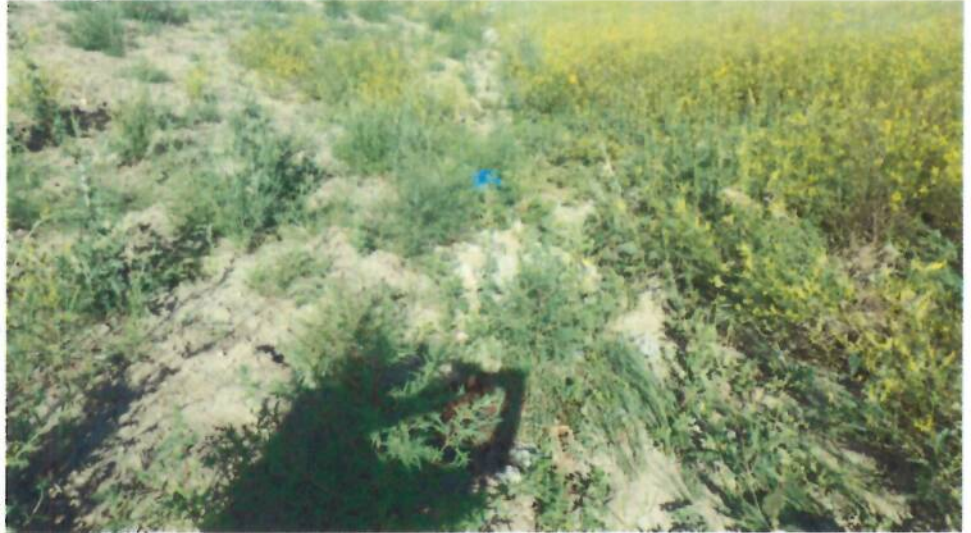
Photo Number: 433

A view at the head of the drainage swale.
Note the bent over plants and the sediment.

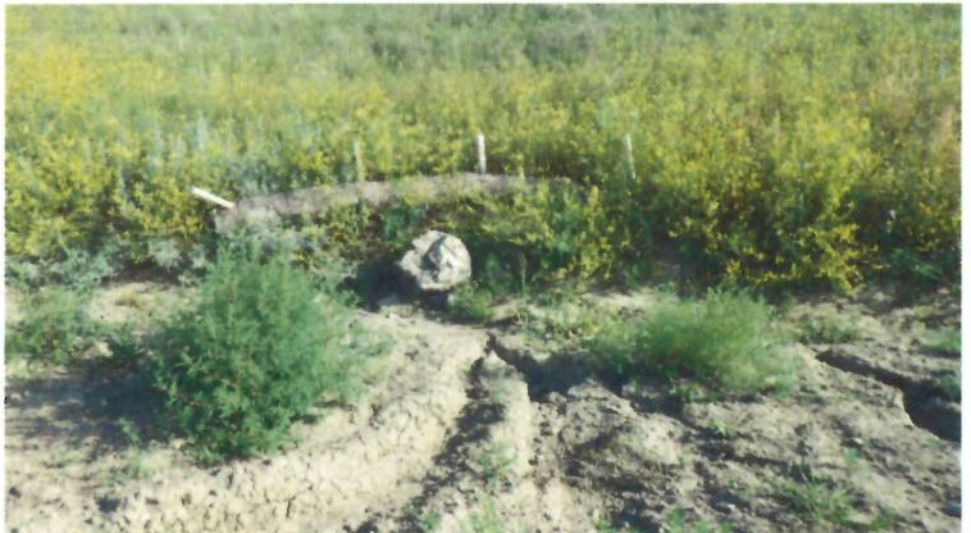
Photo Number: 434

More erosional rills on the northern side of the subdivision. Note the straw wattles at the banks of the drainage swale. The drainage swale runs parallel to the road on the northern side of the subdivision.

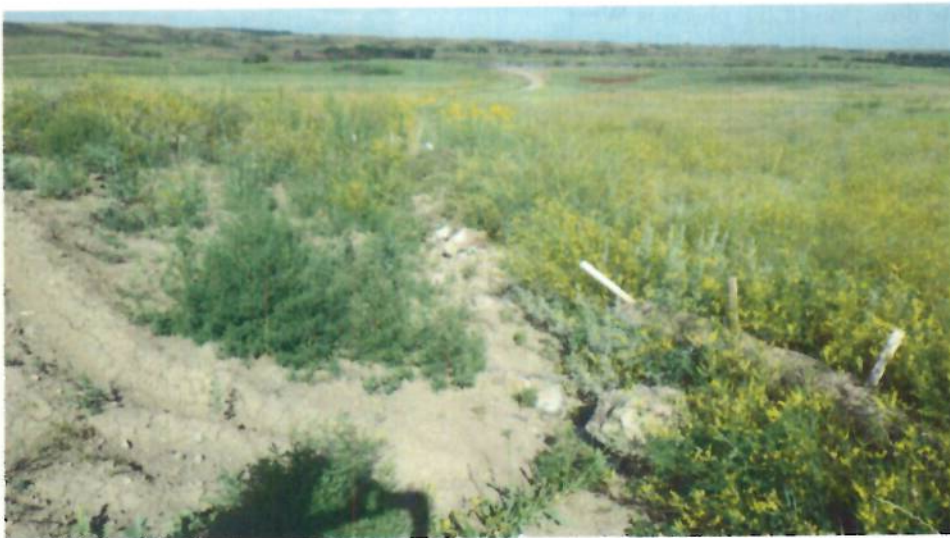
Photo Number: 435

Another view of the drainage swale shown
in photo 434.

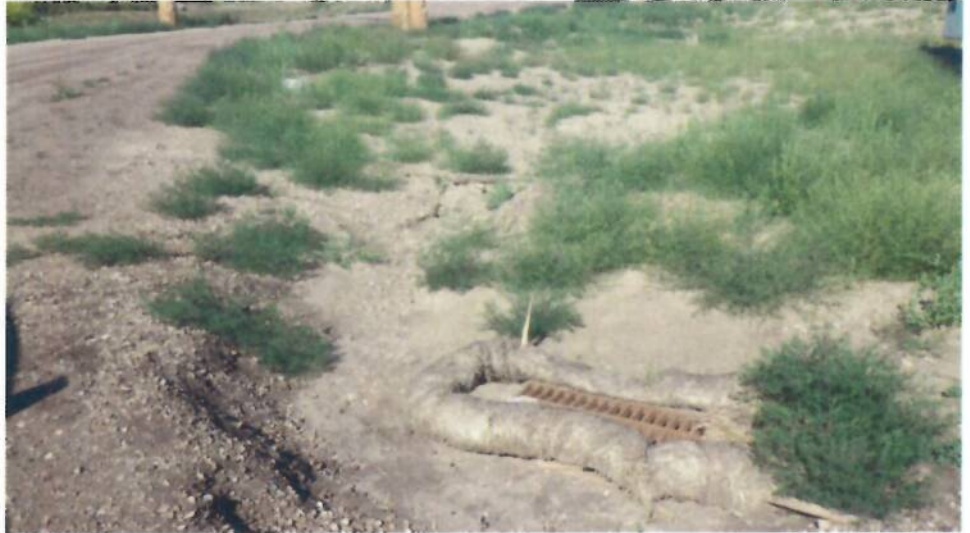
Photo Number: 444
Photo Date/Time: 7/22/2015
Photographer: Kacy Sable
The direction of the photo is West.

An overview of the southern side of the residential park. Note the erosion next to the storm drain.

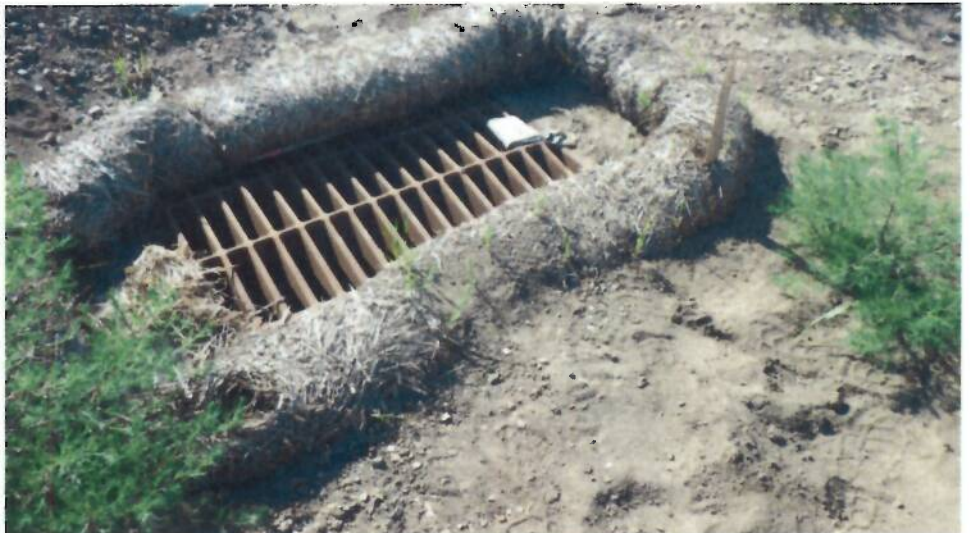
Photo Number: 445
Photo Date/Time: 7/22/2015
Photographer: Kacy Sable

A close-up view of the storm drain shown in photo 444. Note the sediment coming on top of the straw wattle around the storm drain.

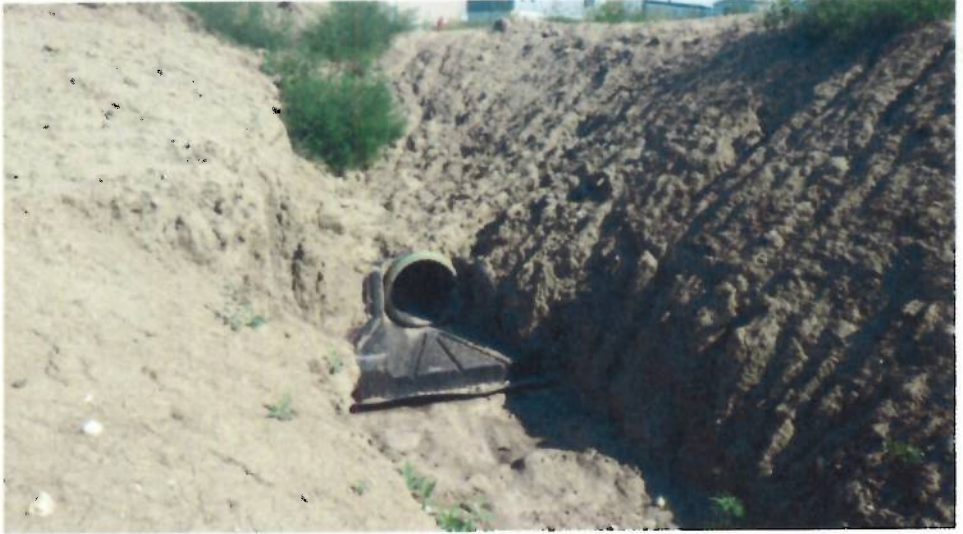
Photo Number: 446
Photo Date/Time: 7/22/2015
Photographer: Kacy Sable
The direction of the photo is East.

A view of an outlet on the west side of the residential park. Note the lack of stabilization on both sides of the outlet.

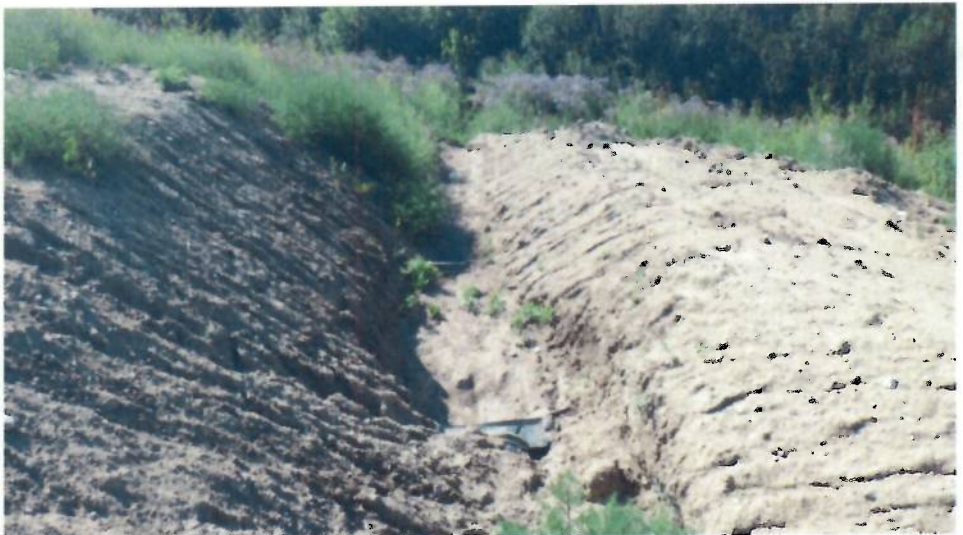
Photo Number: 447
Photo Date/Time: 7/22/2015
Photographer: Kacy Sable
The direction of the photo is East.

A view of the discharge path for the outlet shown in photo 446. Note the erosional rills.

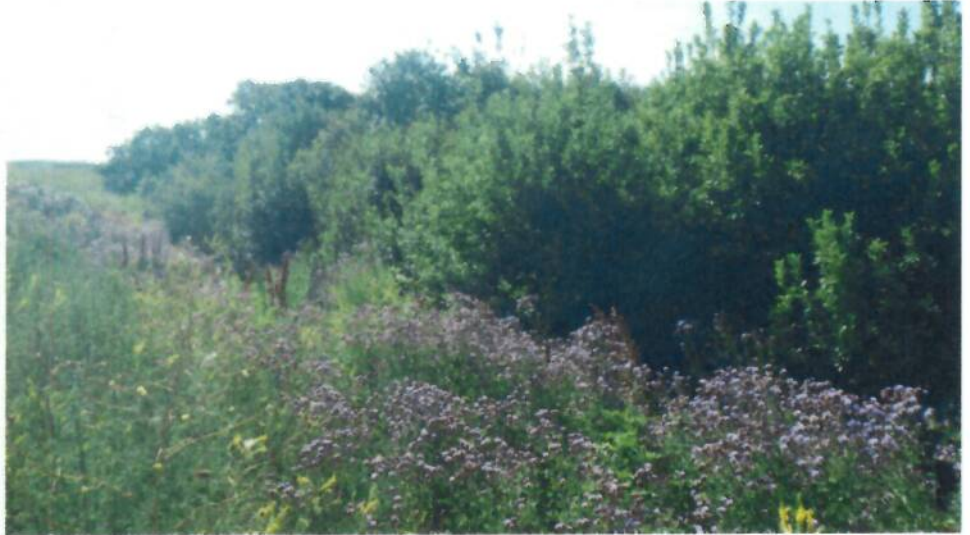
Photo Number: 448

The stormwater discharge location east of the residential park.

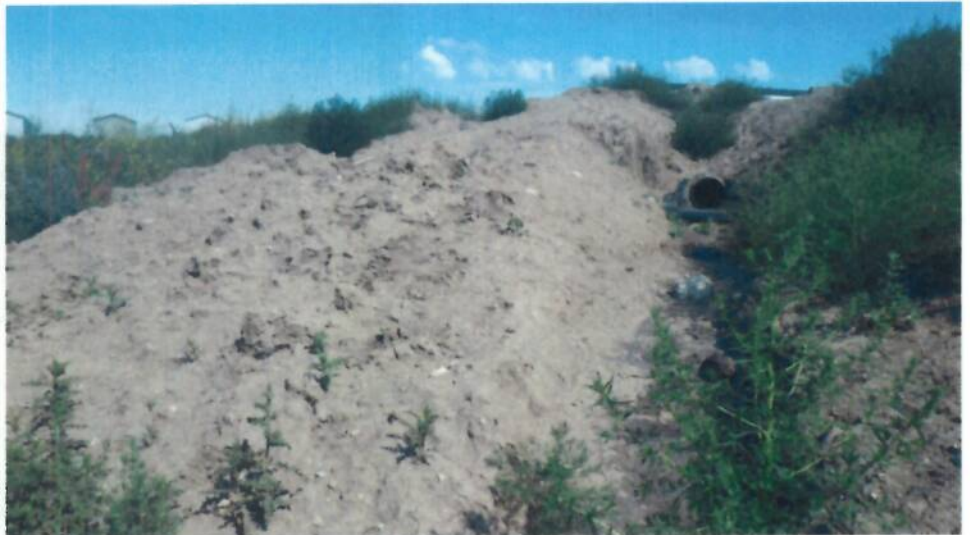
Photo Number: 449

The outlet flow path. Note the lack of stabilization.

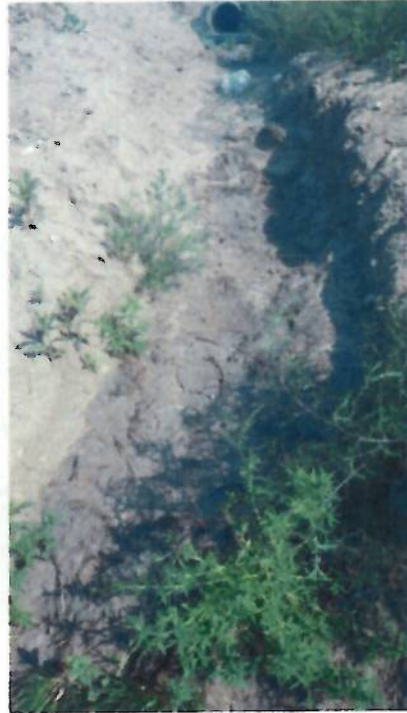
Photo Number: 450
Photo Date/Time: 7/22/2015
Photographer: Kacy Sable

Another view of the flow path shown in photo 449. Note the stains at the bed of the flow path.

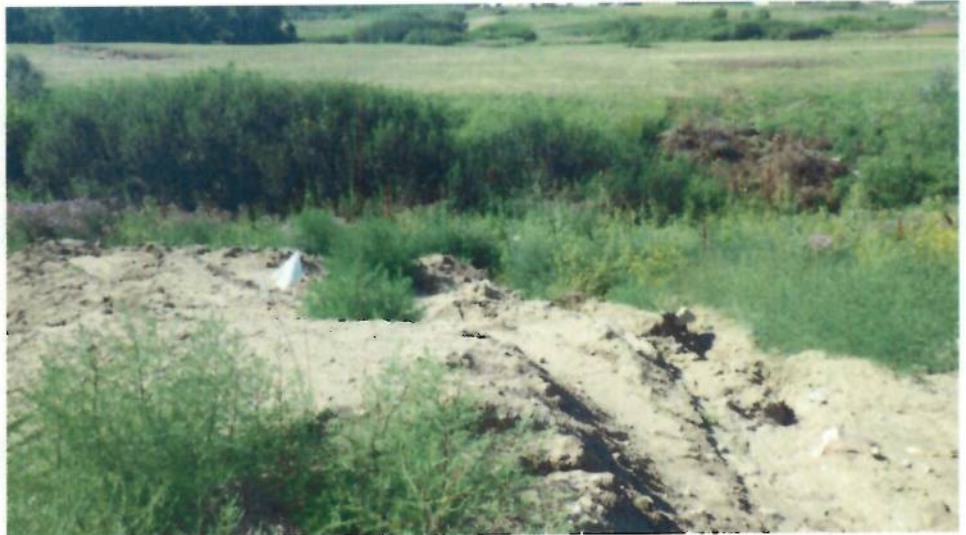
Photo Number: 451
Photo Date/Time: 7/22/2015
Photographer: Kacy Sable
The direction of the photo is East.

A layer of sediment appears to be moving towards the stream on the east side of the residential park.

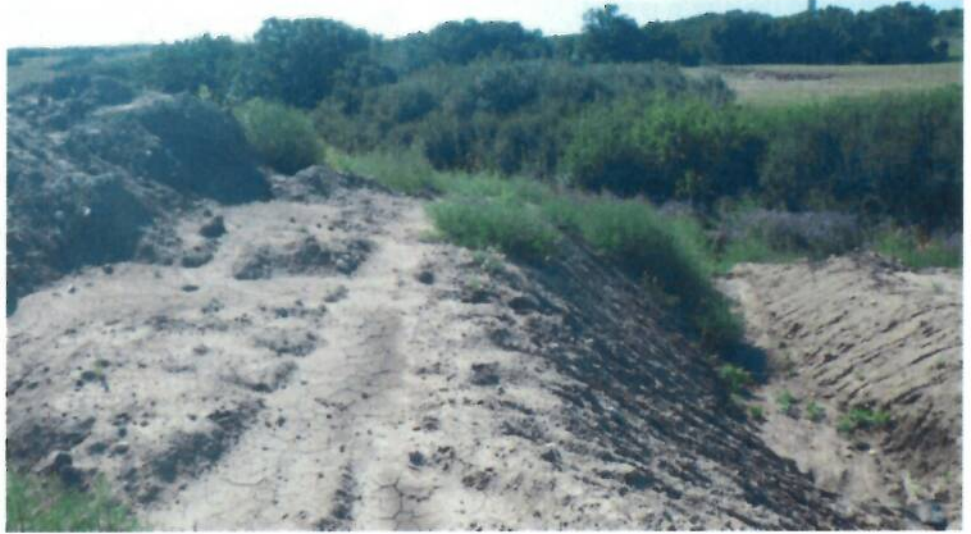
Photo Number: 452

Another view of the sediment pile shown in photo 451.

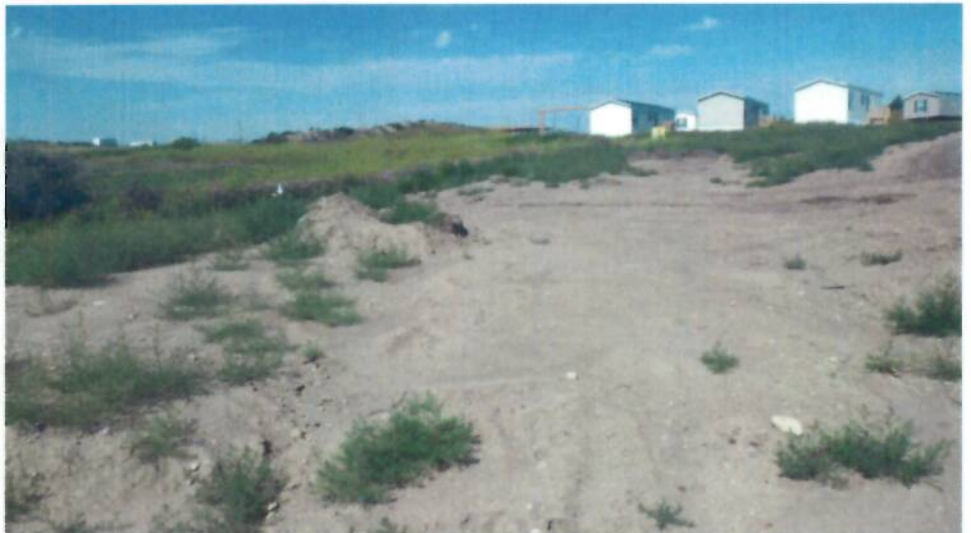
Photo Number: 453

A view of the area next to the road. Note the lack of stabilization.

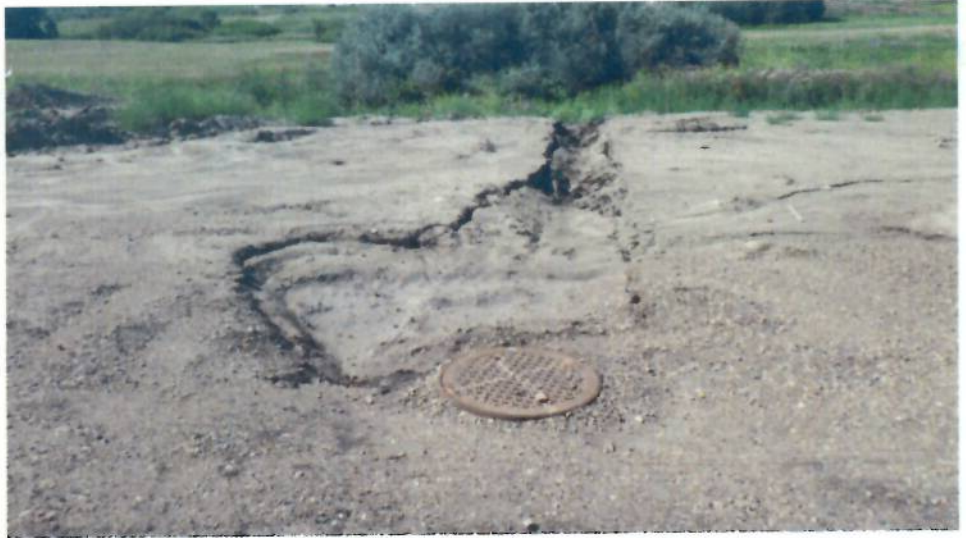
Photo Number: 454
Photo Date/Time: 7/22/2015
Photographer: Kacy Sable
The direction of the photo is East.

A close-up view of the area shown in photo 453. Note the erosion leading to the sewer manhole. The sewer manhole was being destabilized as a result of the erosion.

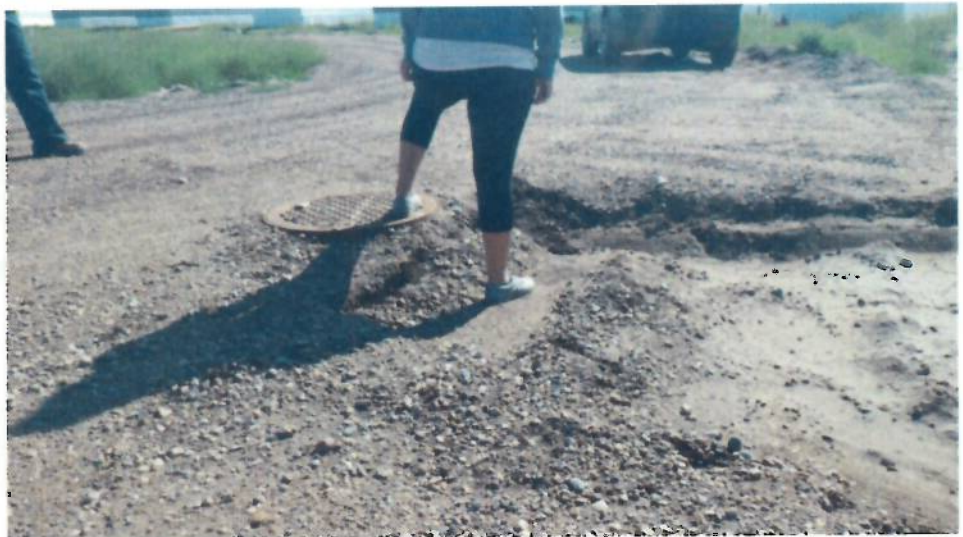
Photo Number: 455
Photo Date/Time: 7/22/2015
Photographer: Kacy Sable

Another view of the sewer manhole showing the extent of the erosion.

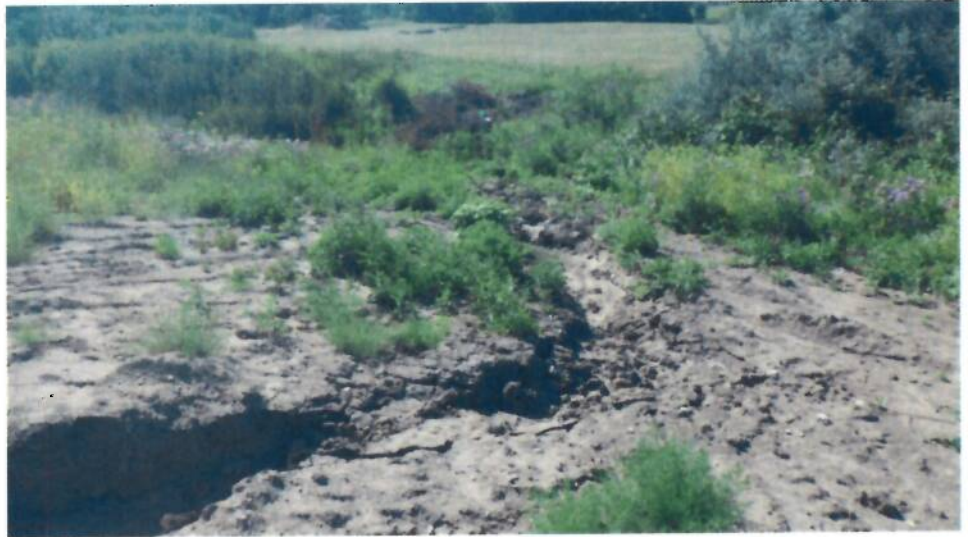
Photo Number: 456

A view of more erosion leading to the stream east of the residential park.

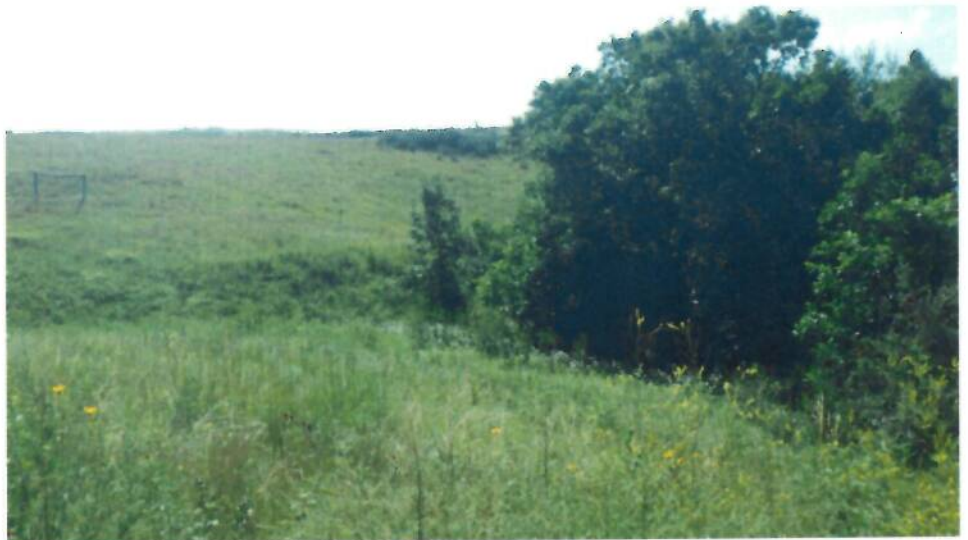
Photo Number: 457

The area east of the residential park where two tributaries connect.
